# acoustic microscopy

## Plastic components

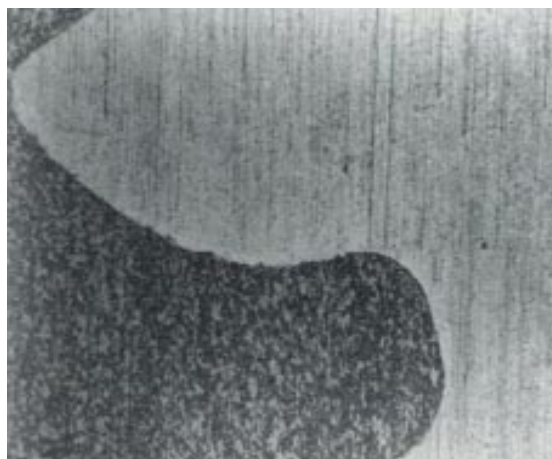
**Fig. b:** On this part of the gear wheel scratches can be seen which were probably caused during aftertreatment of the surface.

**Frequency:** 1,3 GHz

**Image width:** 2 mm
